Amendment to 2018 Report 'Managing the Coast in a Changing Climate'

Box 1.1. A379 Slapton Road - a case study

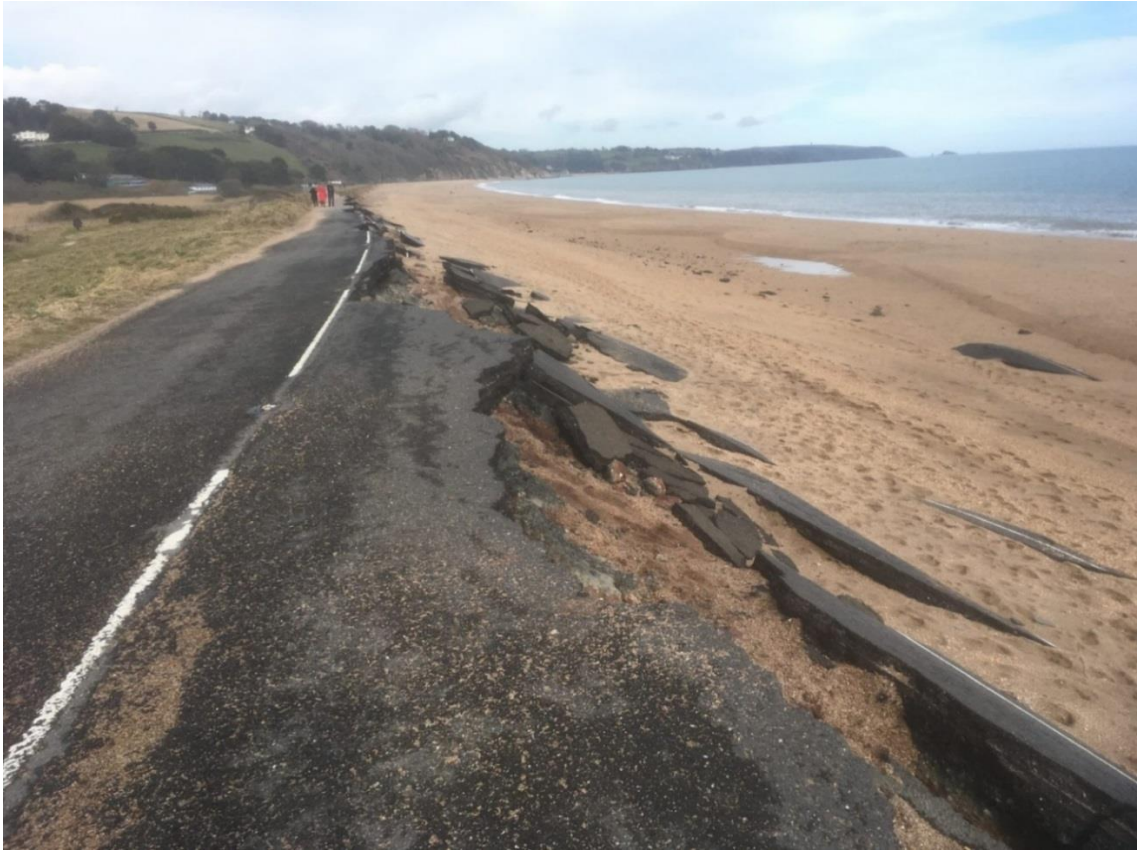
In March 2018, Storm Emma washed away around 400m of the 1.5km stretch of the A379 between Slapton and Strete Gate. The required diversion added around 7km to the journey (25km for HGVs). The road had suffered similar damage in January 2001 when 250m of the road was damaged after a storm.

That section of road was re-built 20m further inland to avoid further, short-term storm damage. Later, in 2007, planning permission was sought, and granted, to rebuild further sections of the A379 around 20m further inland in the event of further damage. Days after the road failure, using the existing technical analyses and plans for road retreat, £2.5M was secured from the Department for Transport. In May, considering the detail, Devon County Council rejected alternative ideas, including closing the road, and agreed to extend the planning permission of 2007 so that a section of road could be re-built around 15m inland thus creating an erosion buffer.
